①
NASA CR-135447

DEFINITION OF MUTUALLY OPTIMUM NDI
AND PROOF TEST CRITERIA FOR
2219 ALUMINUM PRESSURE VESSELS

VOLUME III APPLICATIONS TO RAIL DEFECT EVALUATION

MARTIN MARIETTA CORPORATION

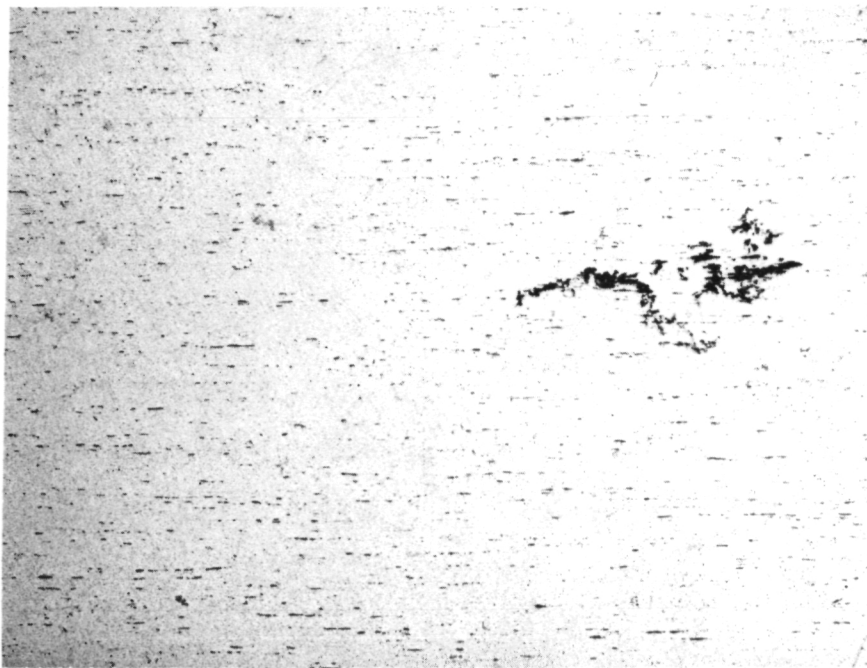
Figure 2. - Longitudinal section through rail obtained from DOT.

Ultrasonic C-scanning using conventional pulse-echo techniques was performed on the as-received first series of rails to locate the defects that required removal from service and to determine the detectability of transverse fissures. The high level of inclusions in the steel produced so many defect indications that operators, unaccustomed to evaluating this type of material, had difficulty establishing the locations of the transverse fissures. The ultrasonic inspection was repeated several times to verify that the indications were due to inclusions. Sectioning and macro-etching confirmed the high level of inclusions. Figure 2 shows such a section.

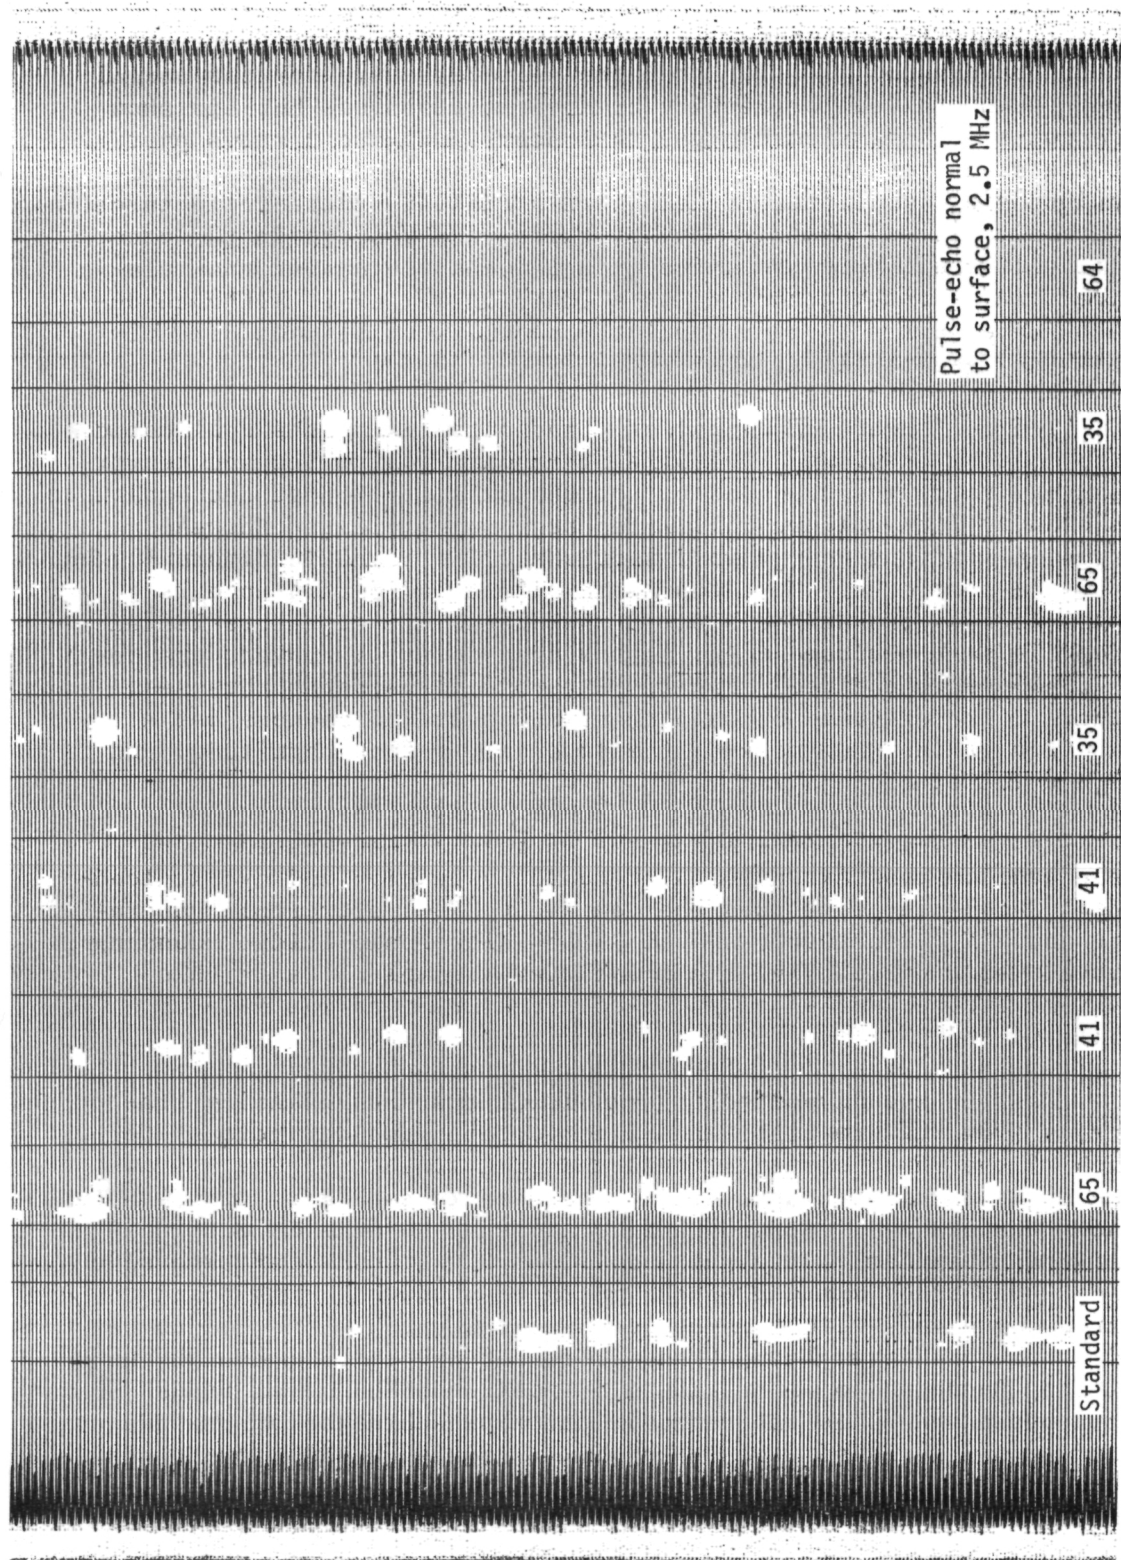
Figure 3. - Pulse-echo scan of DOT rails (side of head).

Rails containing defect location markings were cut into 0.7-m (2-ft) lengths and the heads parted from the web section. Side faces were inspected using the pulse-echo technique with the transducer oriented 90° and 70° from the surface. Data for the normal (90°) scans failed to identify transverse fissures, but did show the numerous inclusions in the rail steel. Figure 3 shows part of the scans for the various sections. Scans made at 70° inclination using two different gain levels indicated defects in three sections. It was unclear whether there were defects in the other rail sections. Note the difference between the number and relative size of the indications as a function of gain. Although defects were apparent, characterization could not be made directly from the C-scans illustrated.

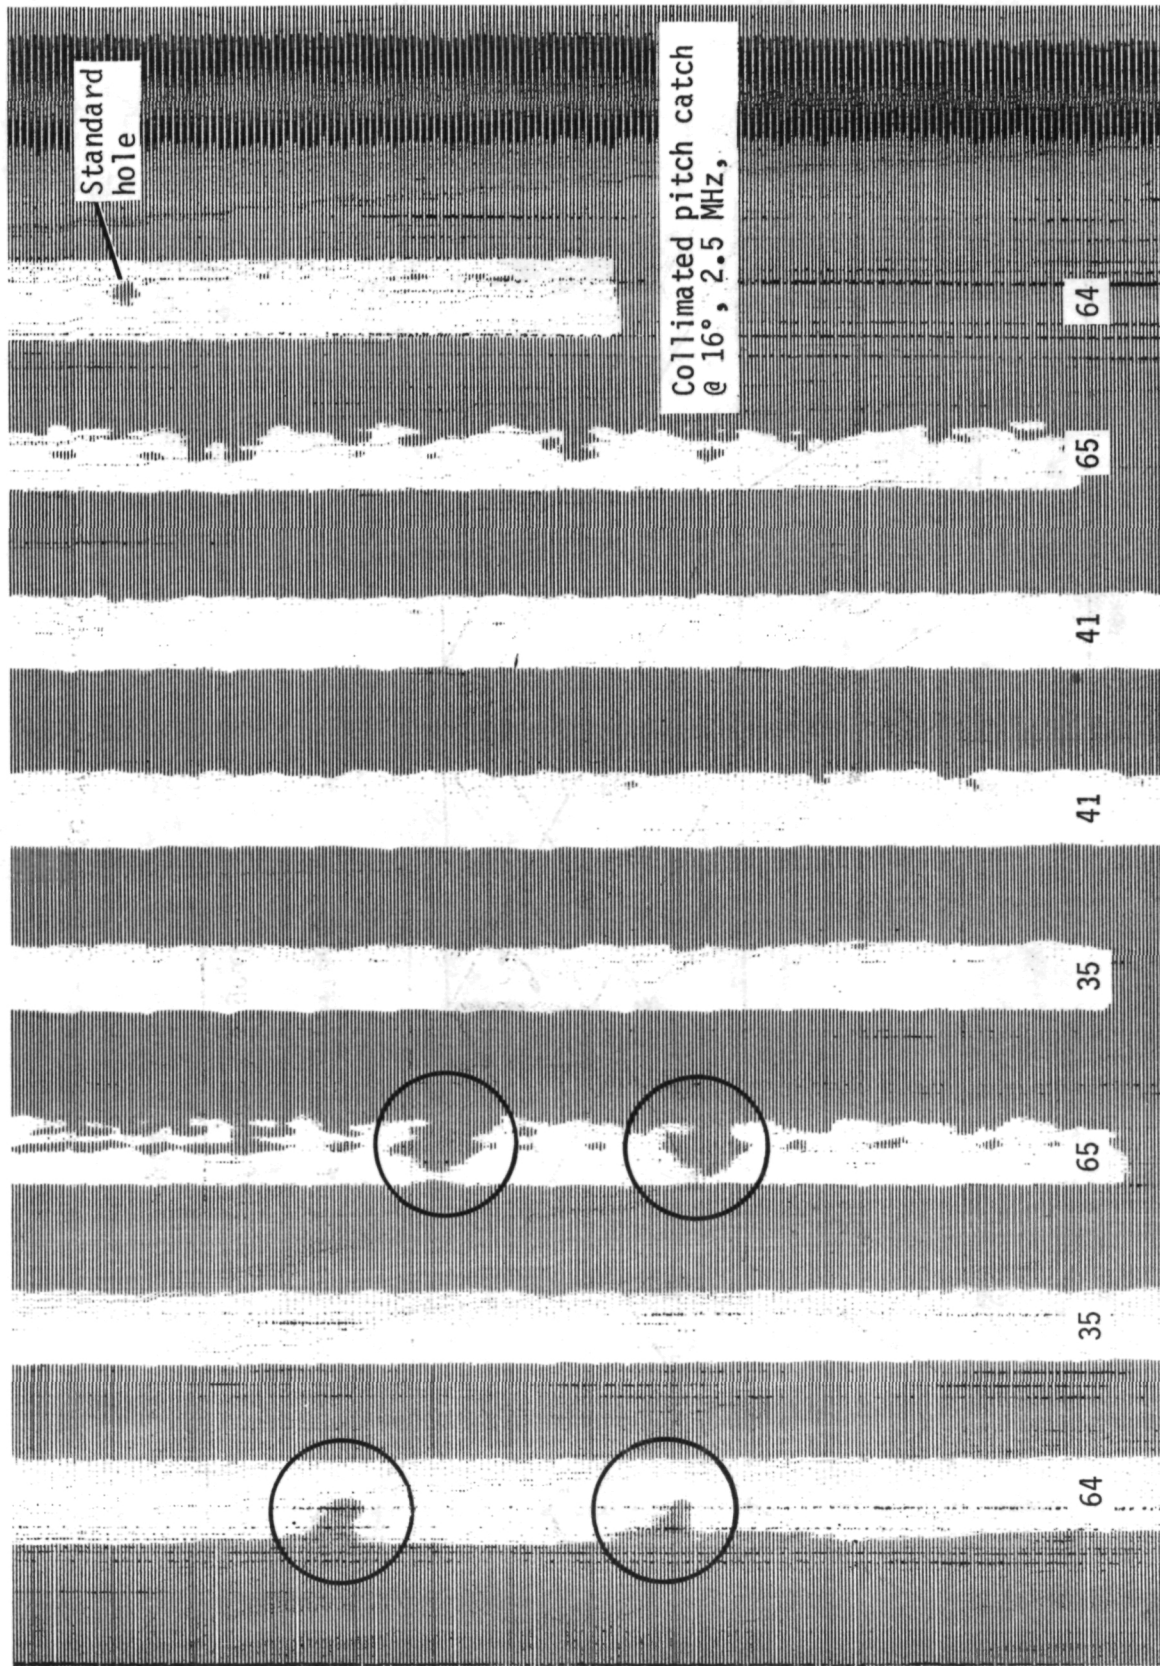
Figure 4. - Collimated pitch-catch scan of DOT rails (side of head).

The rails were ultrasonically inspected using the collimated pitch-catch technique. The same ultrasonic monitoring and traversing apparatus was used except for the substitution of the dual transducer head. These collimated beam scans clearly showed large indications in two rail sections. The scans in figure 4 show these defects. Note that each defect indication appears twice because the defect blocked the ultrasonic signal reflected from the back surface; then, as the transducer was moved, the defect blocked the direct signal. Figure 5 illustrates this sequence. The distance between the two defect indications was a function of the thickness of the material, defect magnitude, and defect location.

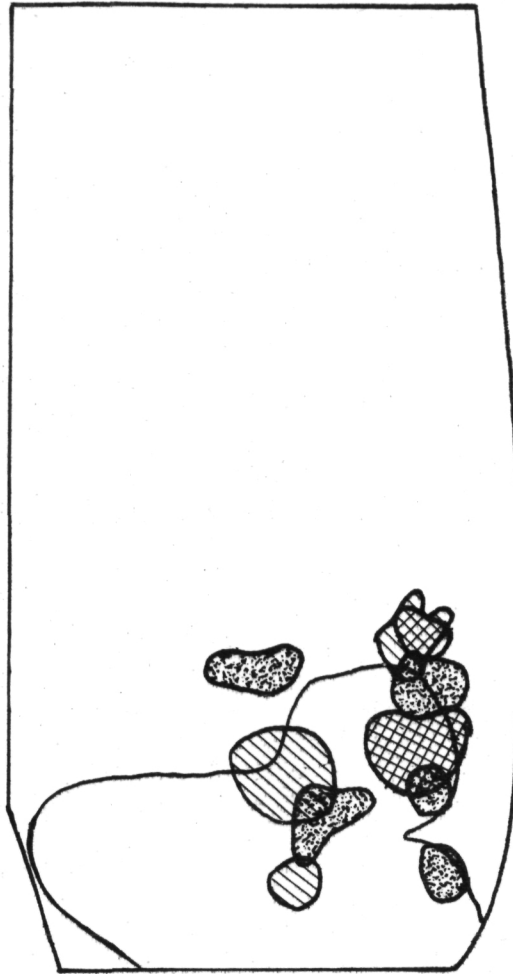
Figure 11. - Characterization of defect in rail 64
obtained by multiple pulse-echo scans.

Rail 64 was similarly evaluated. Two scans failed to show evidence of a defect. Three scans revealed small defect indications and one revealed a large indication. Figure 11 shows the composite of the various scans. Note the significant difference in the size and location of individual indications. The large dotted image was obtained from a top-surface traverse. The top-surface traverse in the opposite direction did not produce any reflection. Traverses from the side surfaces produced small indications grouped together, which suggested that defect characterization might be influenced by detail fracture.* Side-surface

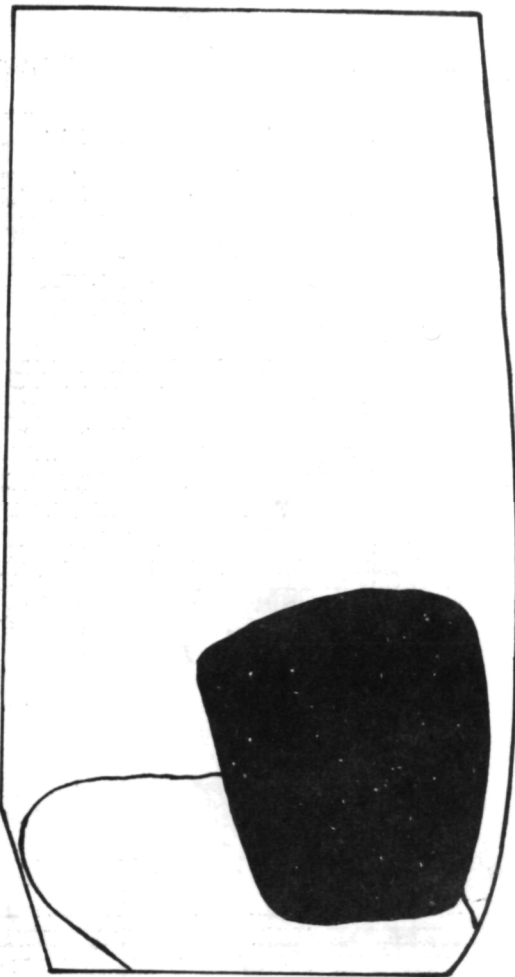
Figure 12. - Characterization of transverse portion of defect in rail 64.

traverses characterized the transverse portion of the defect. Figure 12 illustrates the envelope suggested by the transverse portion.

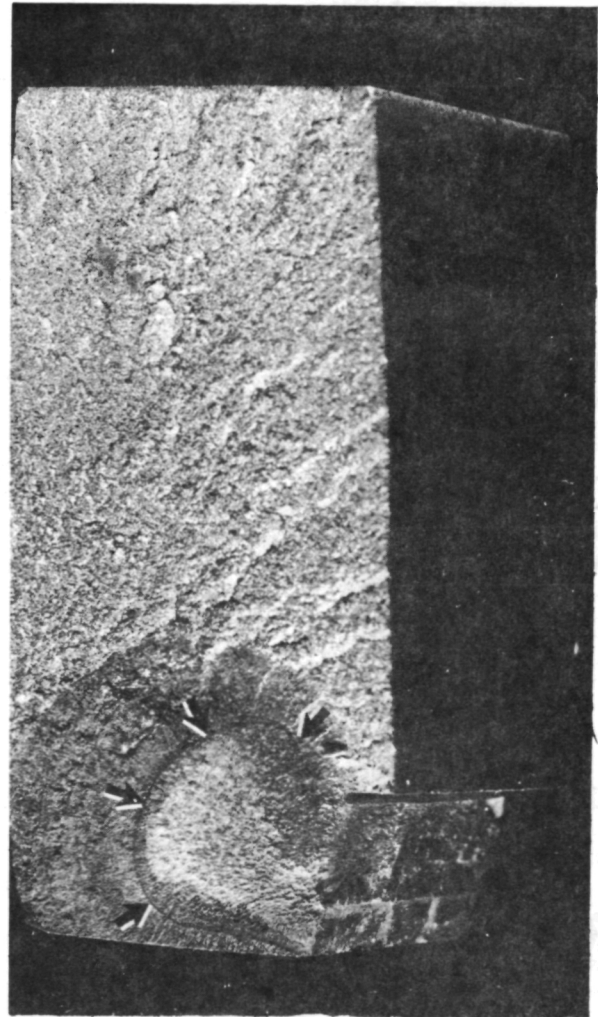
Figure 13. - Fracture surface of rail 64.

Opening the defect confirmed that initiation was in the longitudinal direction and that, during propagation, it rotated to the transverse orientation. Figure 13 shows the fracture surface.

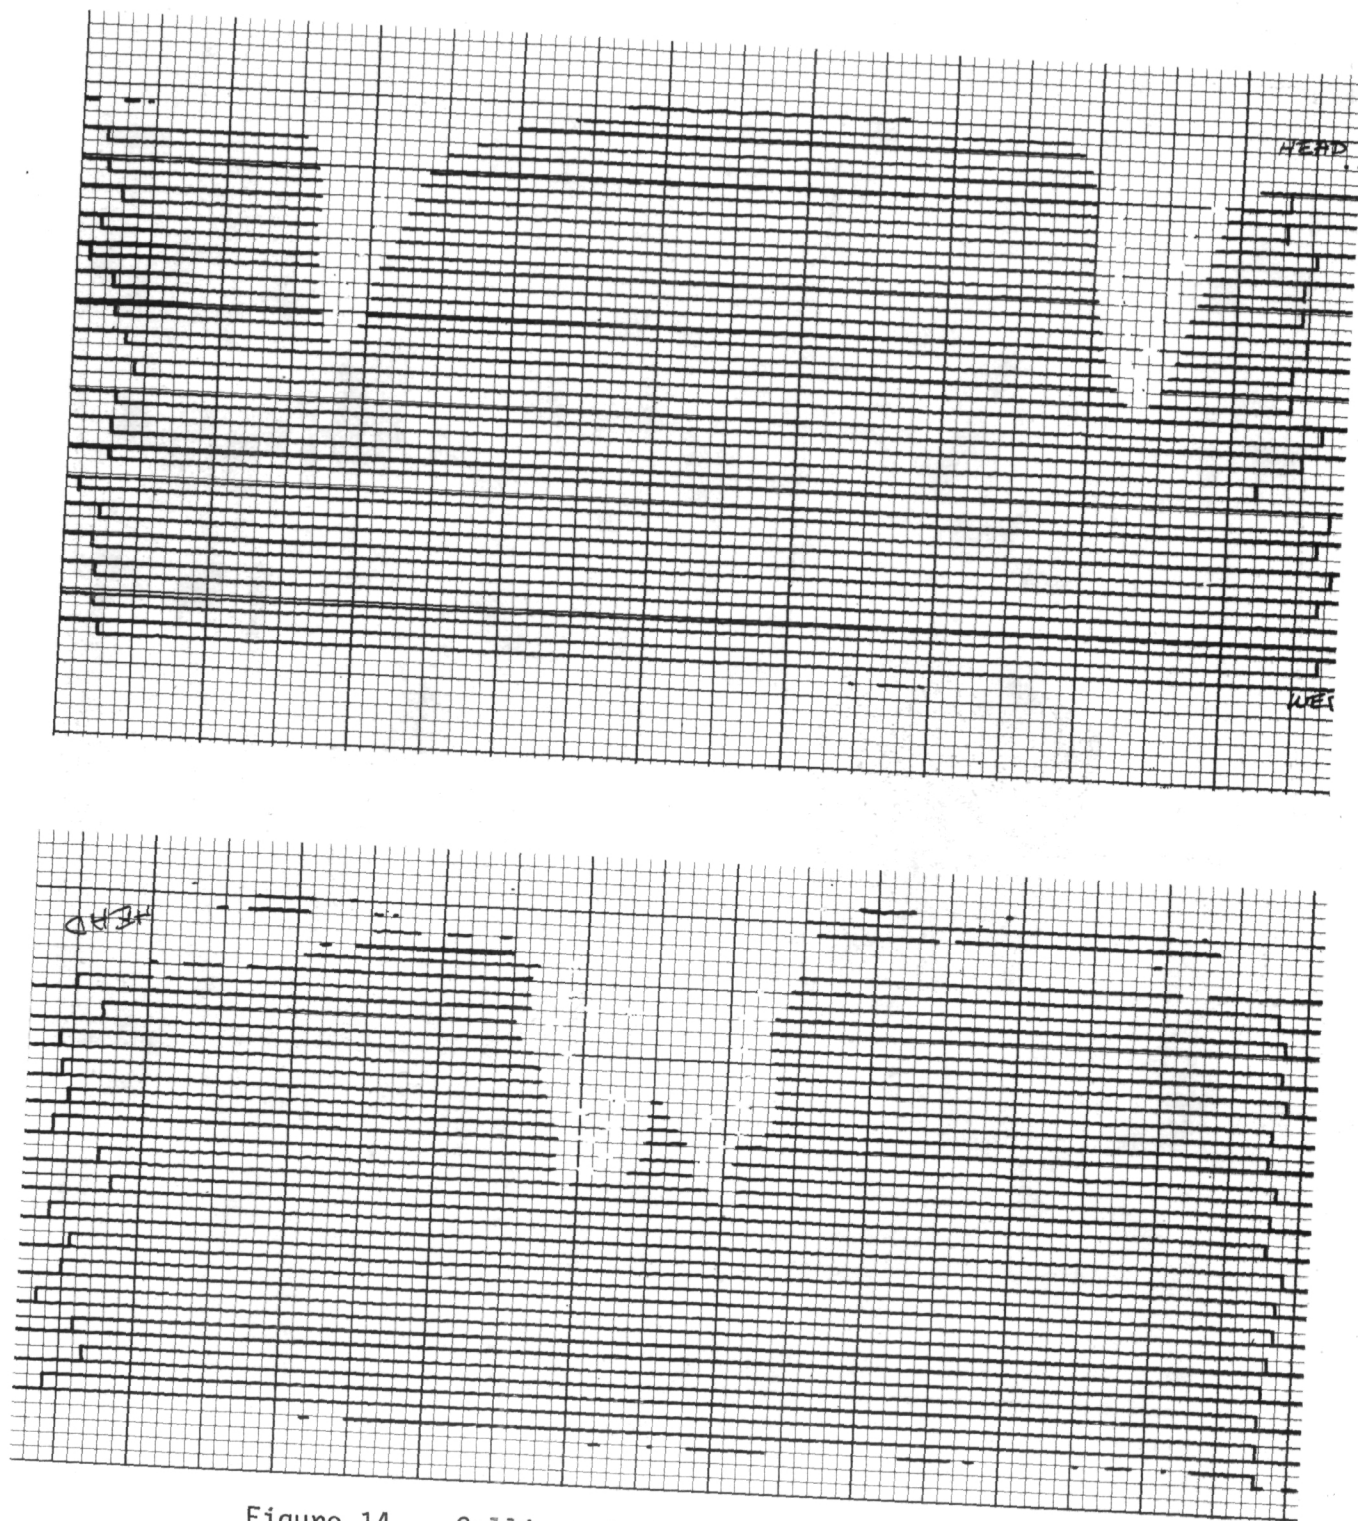
Figure 14. - Collimated pitch-catch data for rail 64
in as-received condition.

Figure 14 illustrates actual rail 64 data evaluated from each side. The trace from one side shows two indications of the defect widely spaced; the trace from the other side shows the indications to be overlapping.* This observation indicated that the defect was quite close to one side. Further study of the figure showed that the defect was near the head. The dissimilarity in size of the two indications suggested an orientation that is not normal to the surface.

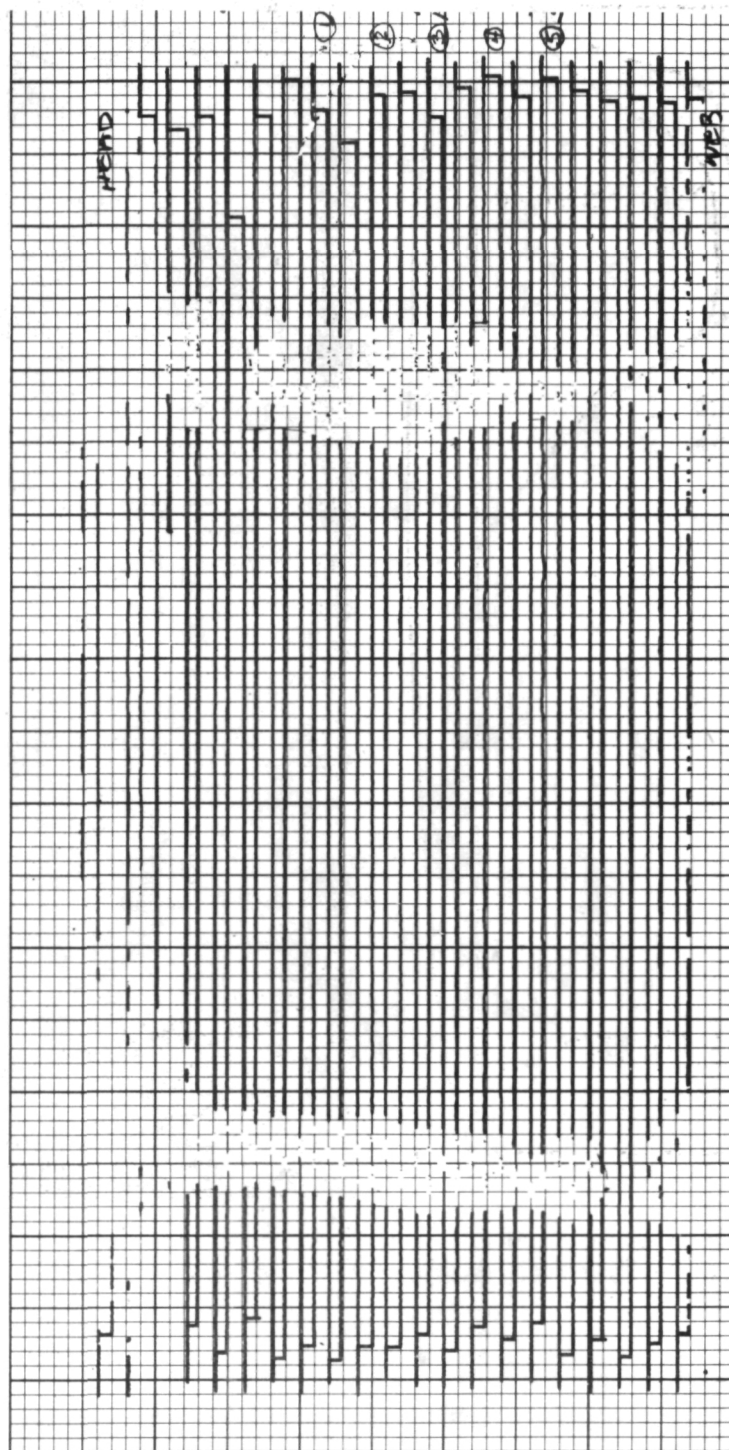
Figure 15. ~ Collimated pitch-catch data for rail 64 after cyclic loading.

To enlarge the defect, the specimen was then subjected to a series of cyclic loadings at 172 MN/m^2 (20 ksi). After each cyclic loading, the rail section was reinspected. The growth band was marked by cycling at a lower stress to produce a small growth band of different appearance. The marking cycle was 5000 reversals at a stress of 138 MN/m^2 (20 ksi). Five growth and inspection sequences were performed. Figure 15 is an ultrasonic record after cycling in which depth growth was apparent. For additional clarity, ink blots have been removed, and a flaw map of these data transformed to true shape. Figure 16 shows a fracture-face photograph.

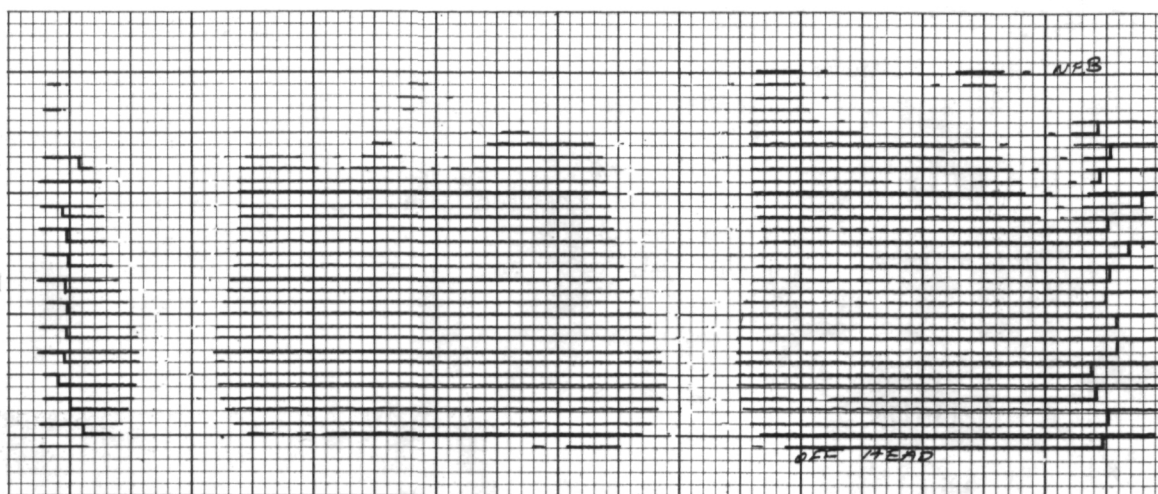
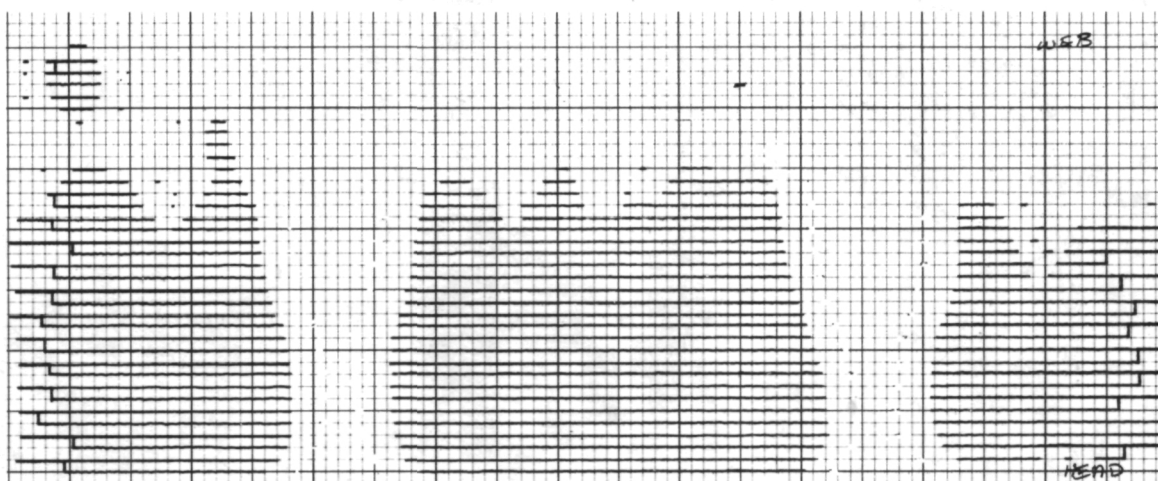
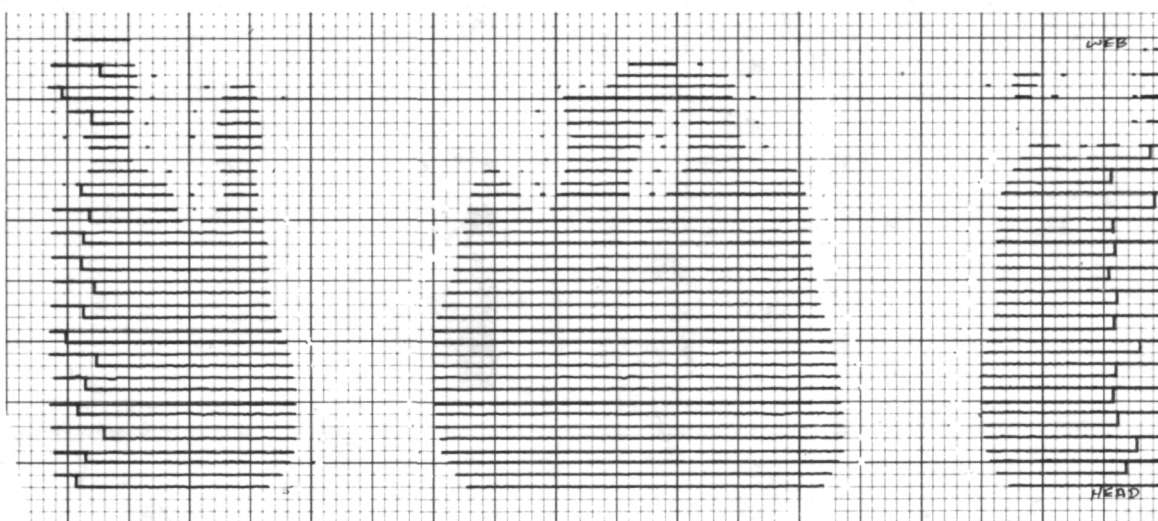
Figure 17. - Collimated pitch-catch data for rail 65 in as-received condition and after cycling.

Rail 65 was similarly inspected, cycled, and reinspected using the collimated pitch-catch ultrasonic technique. Actual data traces are combined in figure 17 to illustrate growth resulting from cycling. The data traces suggest that the defect extends

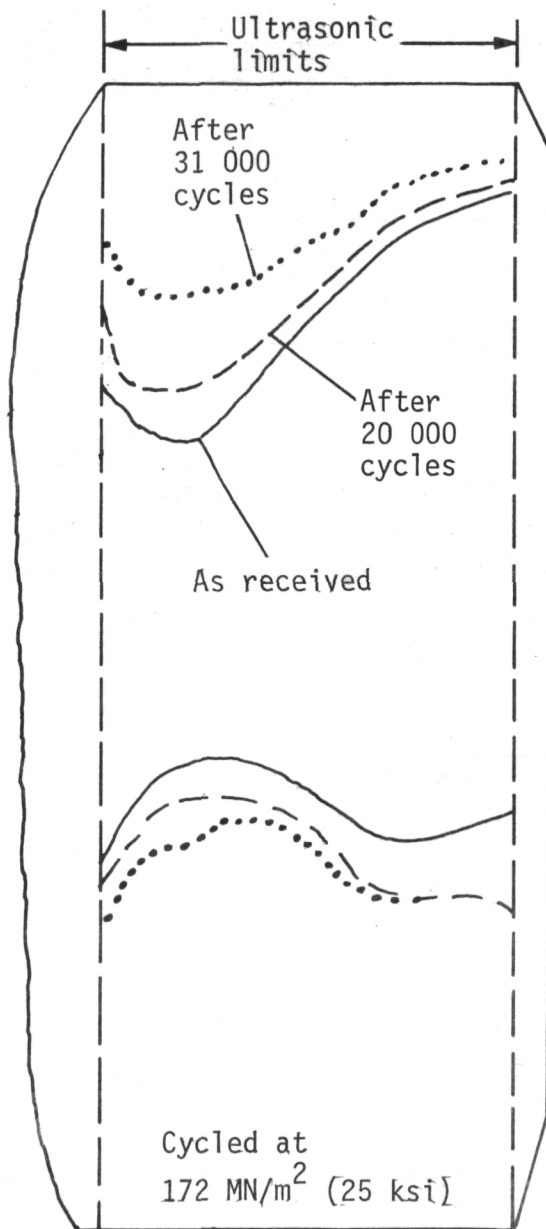
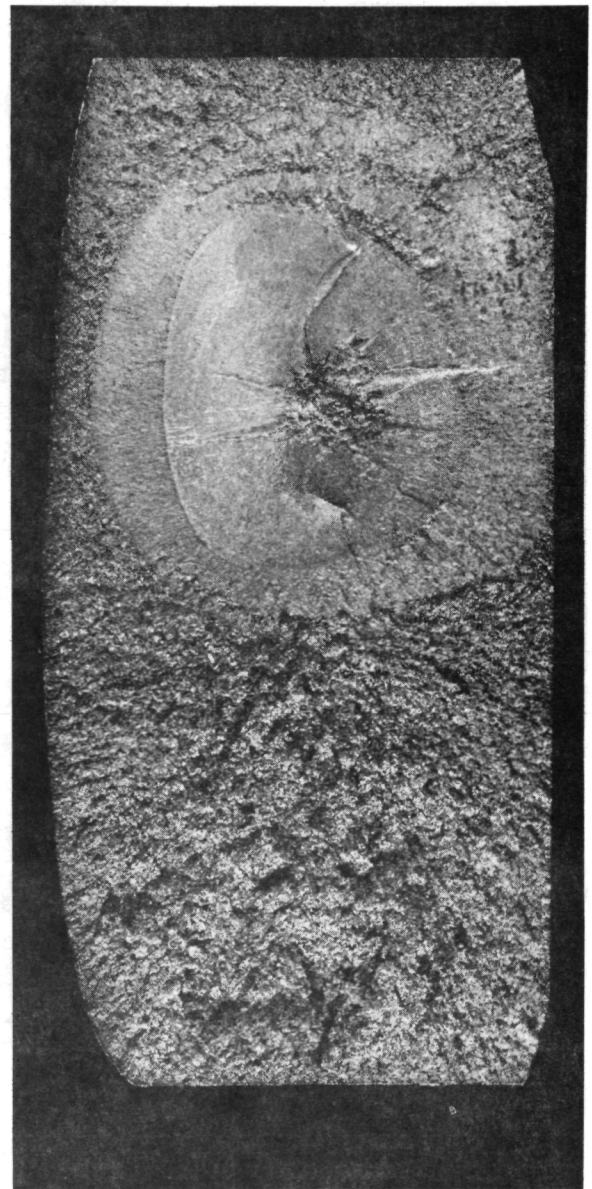
Figure 18. - Pitch-catch flaw map and fractograph of rail 65.

through the entire section from head to web. The traces also suggest an hourglass shape for the defect. The fractograph in figure 18 shows the defect to be totally embedded; a flaw map constructed from the data is also shown.

The results of this part of the evaluation show that, although crack growth could be tracked, the ability to map the entire cross section was limited. It appeared that only the central portion could be adequately monitored. As the head and web surfaces were approached, the ultrasonic signal did not validly represent the defect shape.

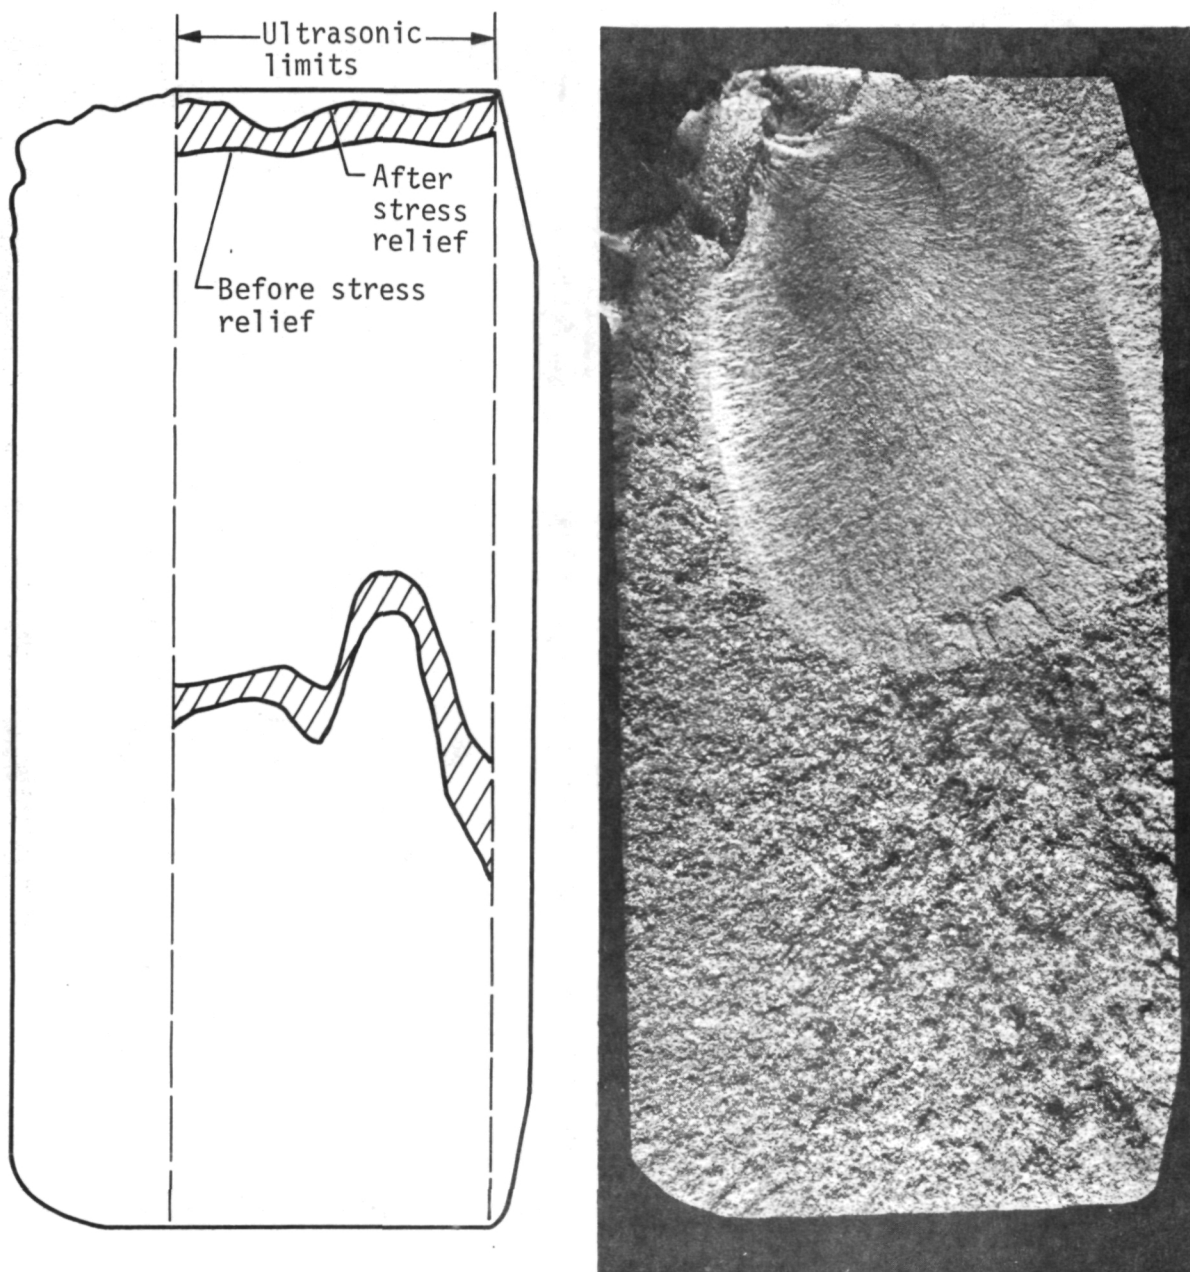
Figure 19. - Pitch-catch flaw map and fractograph of rail 1.

The second series of rails (1 through 6) was evaluated using the ultrasonic pitch-catch technique. Rail 1 was ultrasonically inspected, then stress relieved at 538 C (1000°F) for 2 hours and reinspected. Ultrasonic inspection indicated that the defect extended from close to one surface to approximately halfway across the width; the defect was shown to be at least 2 cm (0.8 in.) high. Figure 19 shows a fractograph of the defect and the flaw map drawn before opening. Stress relieving had little effect on the appearance of the defect.

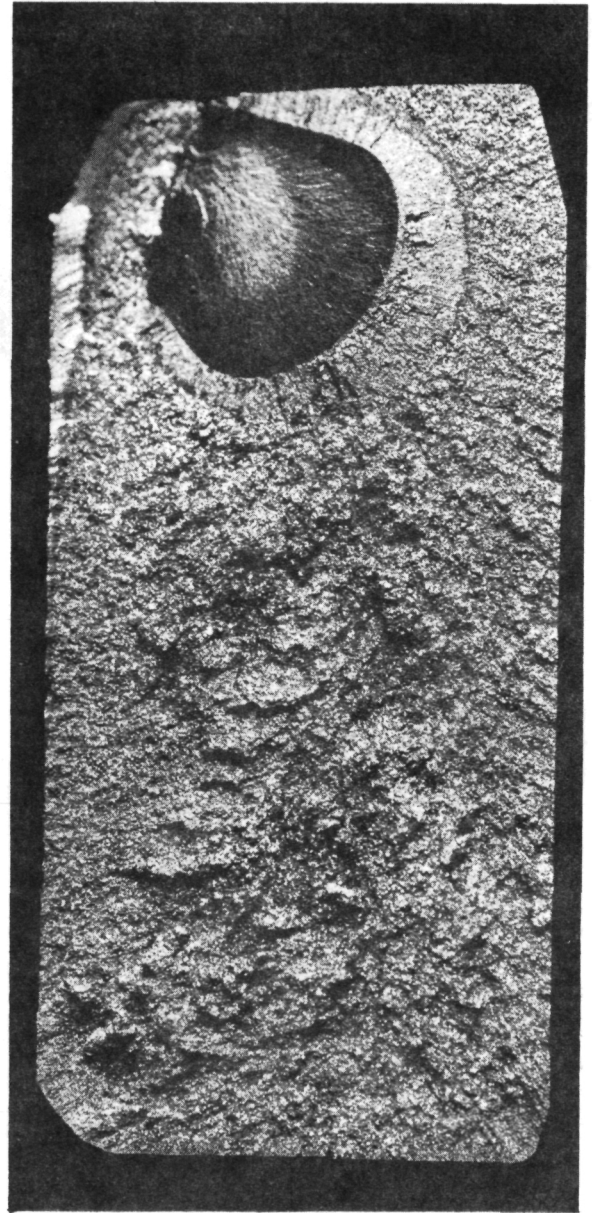
Figure 20. - Pitch-catch flaw map and fractograph of rail 2.

Rail 2 was inspected, cycled, and reinspected. Agreement between the flaw map and fractograph was relatively good, as shown in figure 20.

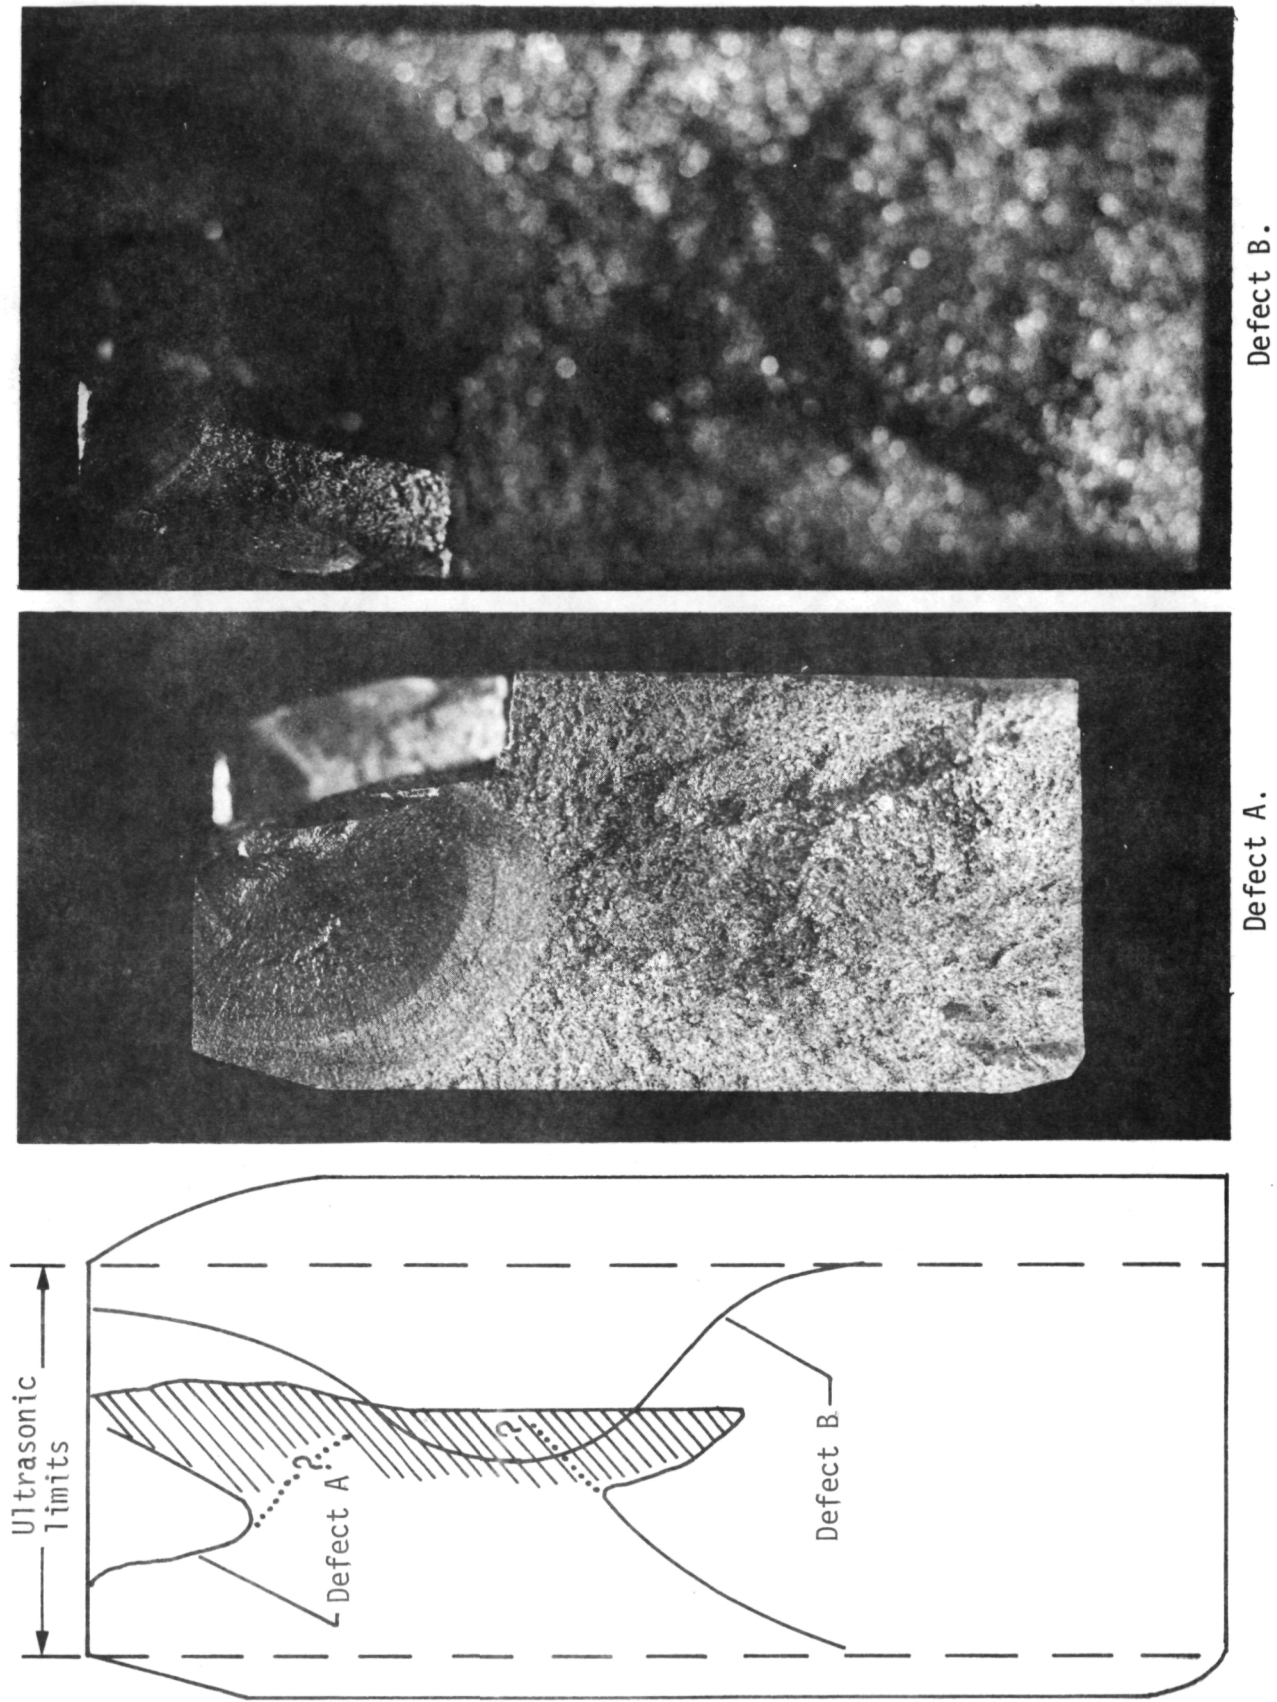
Figure 21. - Pitch-catch flaw map and fractographs of rail 3.

Rail 3 showed a large defect indication. Actually, two defects in close proximity were noted. The flaw maps indicated large defects of irregular shape. We surmised that part of the indication resulted from a detail fracture oriented so that it partially

blocked the ultrasonic signal. Figure 21 shows the flaw map and views of the two transverse fracture faces. The flaw map identifies defects A and B. Defect A narrowed as it extended into the center of the rail, then suddenly widened. The widening was probably caused by detection of the detail portion of the fracture and is shaded in the flaw map. As anticipated, the detail portion of the defect was skewed and would mask the ultrasonic signal. Figure 22 is a photo of the two defects in rail 3 showing their relative proximity.

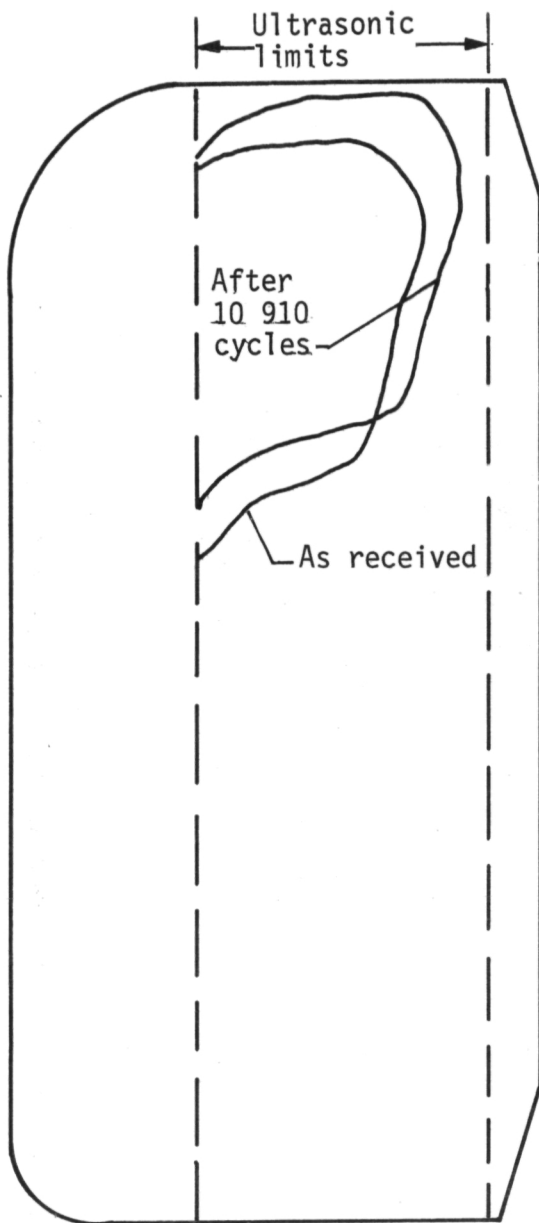
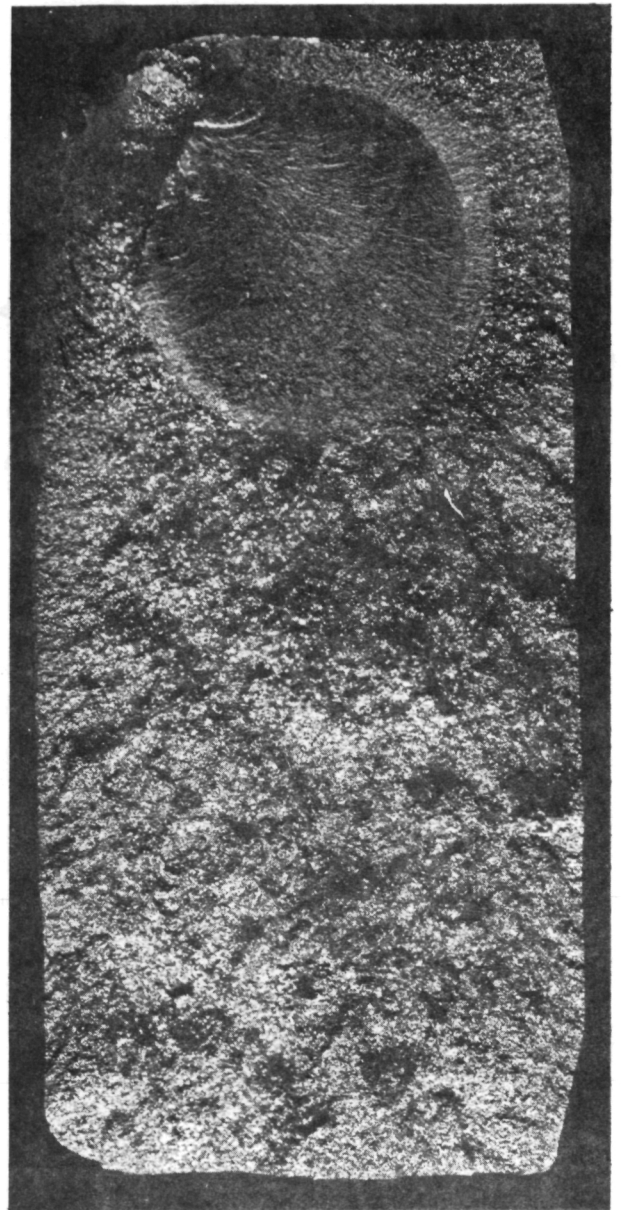
Figure 23. - Pitch-catch flaw map and fractograph of rail 4.

Rail 4 was inspected, stress relieved, inspected, then cycled and reinspected. Stress relieving did not produce significant changes in flaw character. Figure 23 shows the flaw map and fractograph.

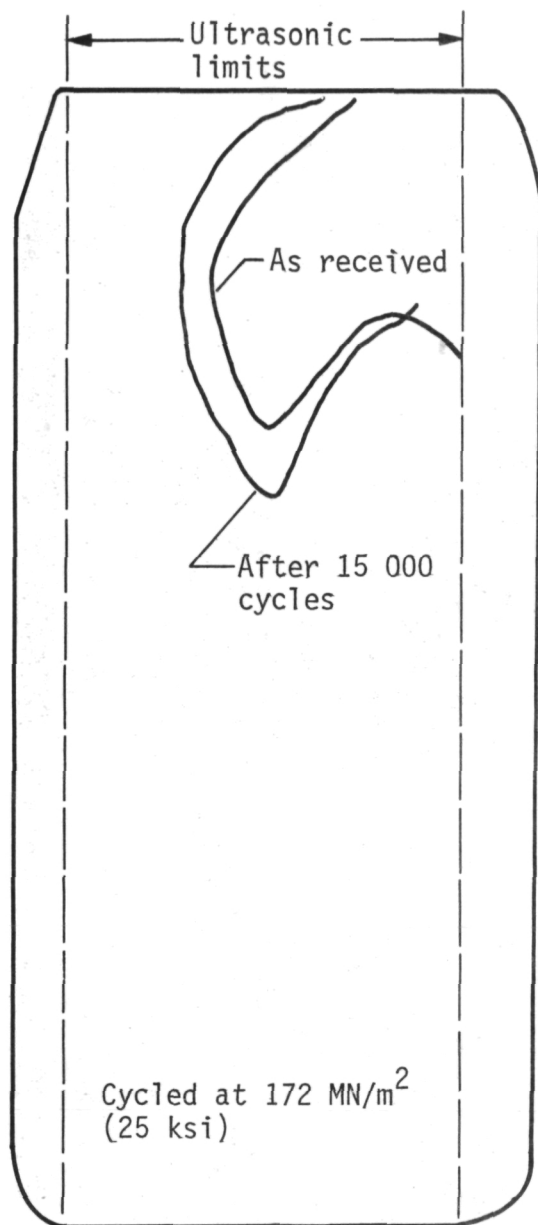
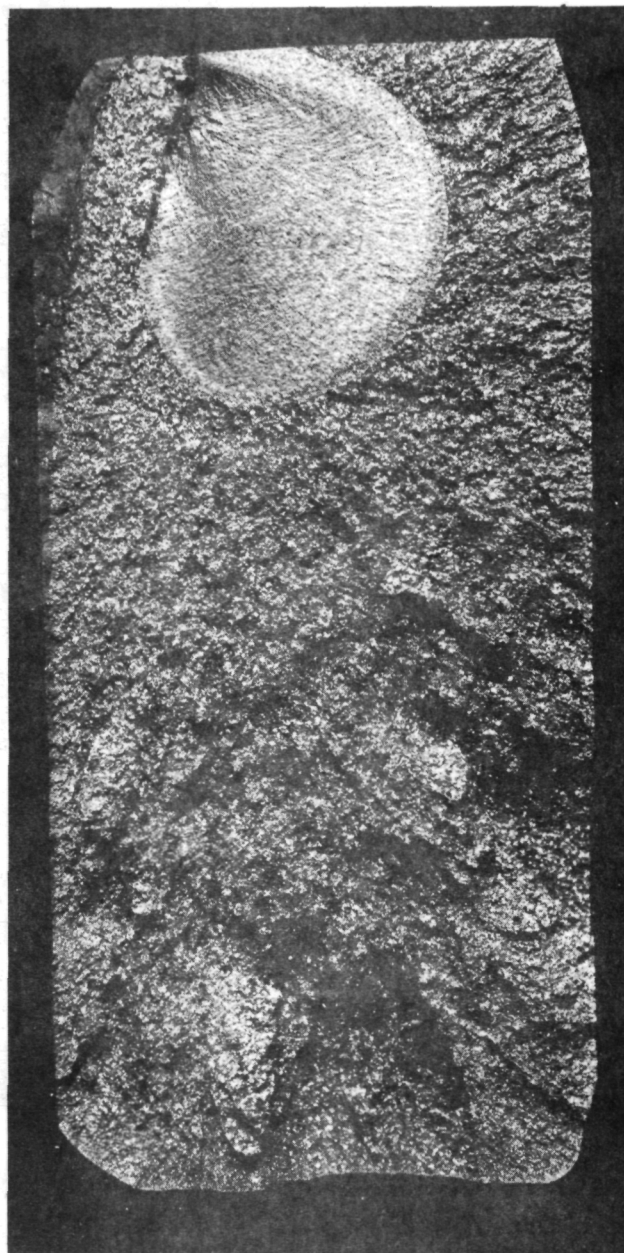
Figure 25. - Pitch-catch flaw map and fractograph of rail 6.

Rails 5 and 6 were inspected, cycled, and reinspected. As shown in figures 24 and 25, agreement between the flaw map and fractograph was reasonably good.
